SPACE SHUTTLE ORBITER  
APPROACH AND LANDING TEST  
FINAL EVALUATION REPORT

NATIONAL AERONAUTICS AND SPACE ADMINISTRATION  
LYNDON B. JOHNSON SPACE CENTER  
HOUSTON, TEXAS  
February 1978

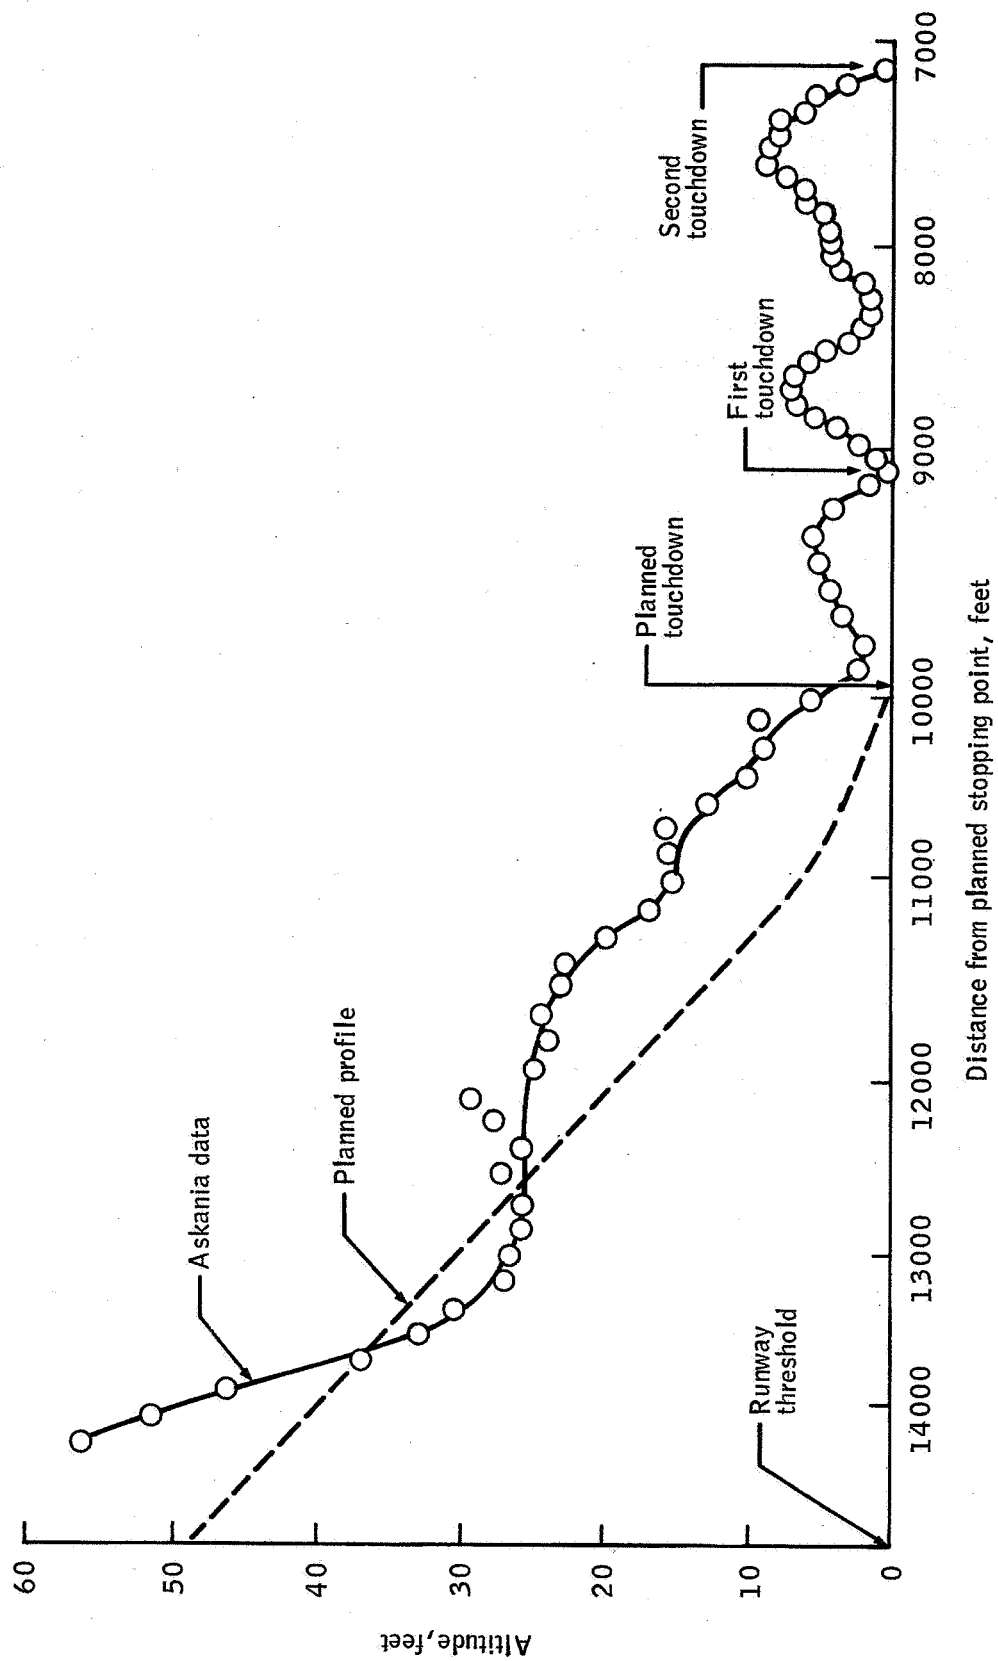
Figure 4-29.- Altitude versus runway position during landing.

After almost touching down, the vehicle ballooned slightly, then touched down smoothly 1000 feet beyond the planned point. The vehicle then skipped gradually back into the air and touched more firmly 6 seconds later, rebounding slightly. Figure 4-29 shows the actual altitude versus runway position during the touchdown sequence. Pitch inputs were made between the touchdowns to keep the vehicle airborne until roll oscillations could be damped. During this entire period, pitch control of altitude and sink rate seemed normal. However, a review of flight data indicates that pitch rate oscillations of  $\pm 3^\circ$  per second occurred during this interval which caused elevon rate saturation. It is significant that these pitch oscillations were not apparent to either crewman at the time from visual or physiological cues. The crew impression was that the pitch rotational hand controller commands were small in amplitude which is contrary to the up-to-half deflection shown in the postflight data. This impression is possibly due to the light stick force gradient, whereby deflection is related to the response noted as compared to actual stick movement. There was an additional 10 percent speed-brake-open command to approximately 60 percent at 15:54:24.5, just before the near-touchdown. This cannot be accounted for except by an inadvertent movement of the speed brake controller.

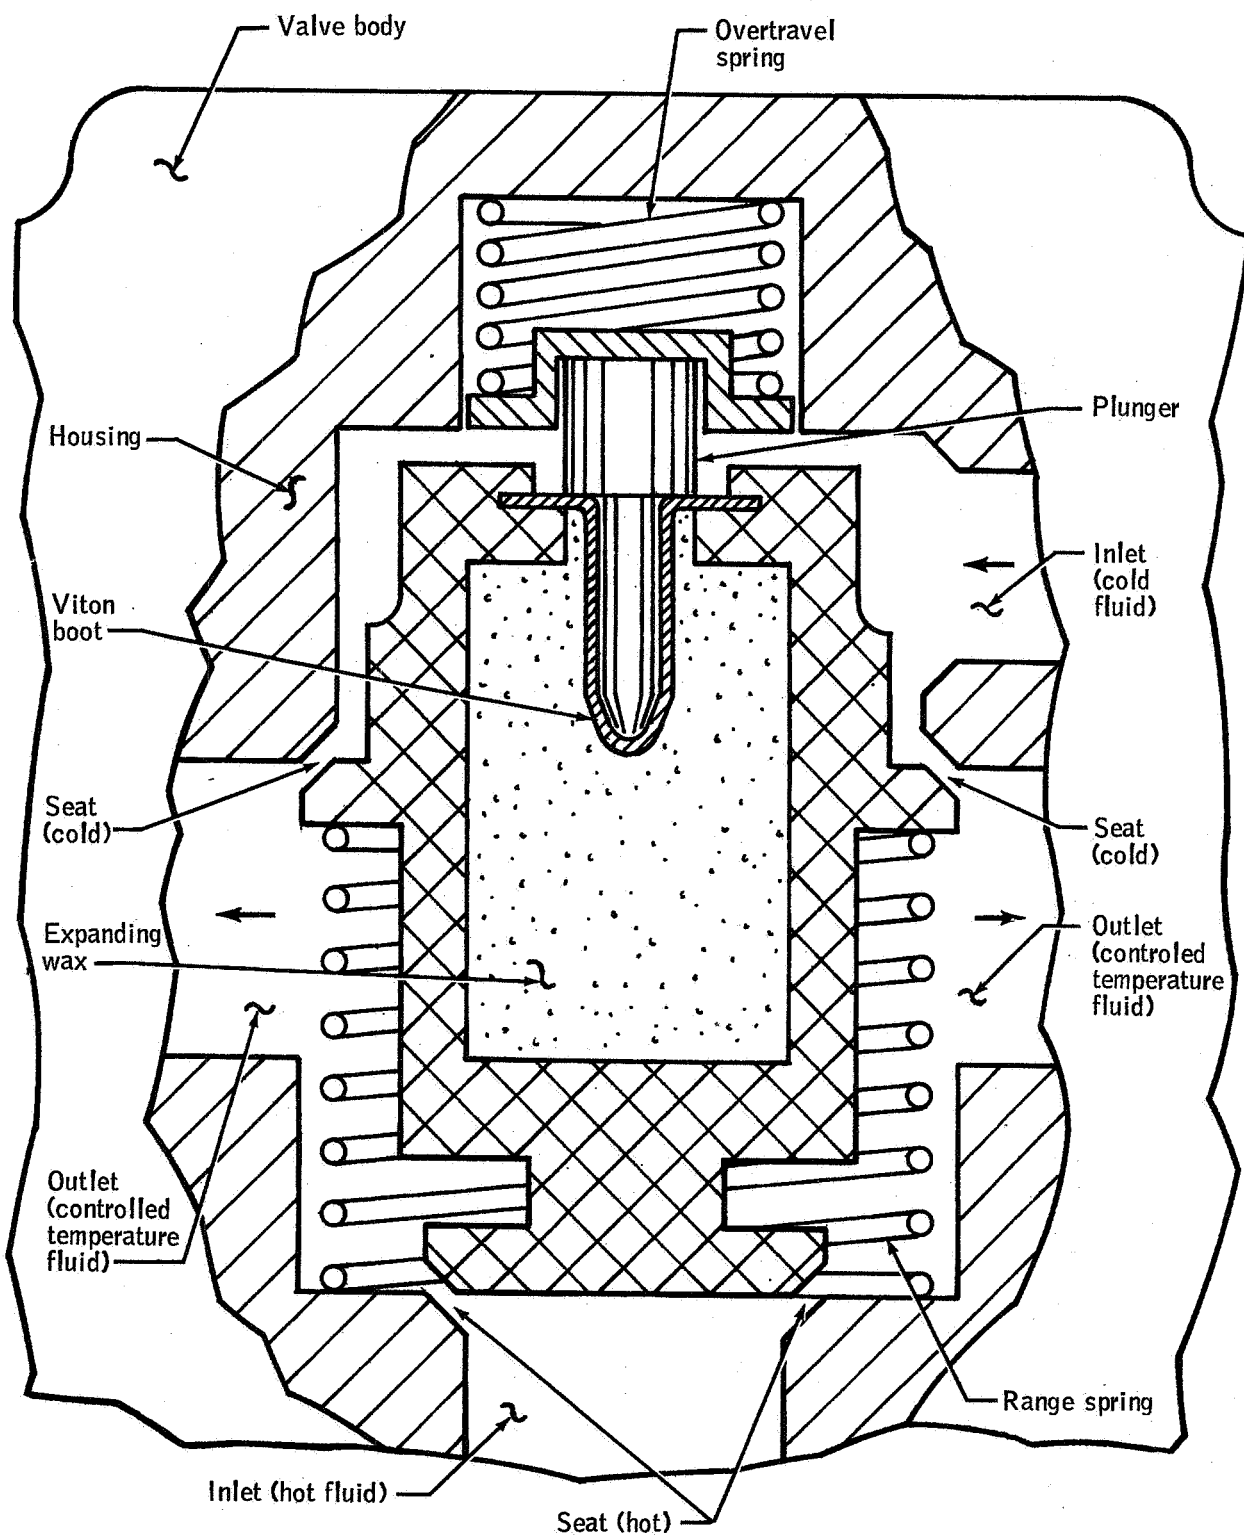
Figure 7-7.- Typical fuel cell thermal control valve (simplified).

After switchover from ground support equipment to internal power and the fuel cell purge during preflight operations for free flight 3, the condenser exit hydrogen temperature reached a low of about 136° F, compared to a normal reading of 142° to 148° F. Prior to this time, the temperature central point had been in the normal range. The 136° F temperature corresponds to an electrolyte concentration of about 46 percent potassium hydroxide. The flight limit is 48 percent potassium hydroxide, which corresponds to a condenser exit hydrogen temperature of 125° F for the observed operating conditions. Operation at temperatures lower than 125° F can cause localized drying out and potential loss of the fuel cell.

The condenser exit temperature is controlled by selective mixing of hot and cold coolant by the condenser exit temperature control valve. The mix position of the valve (fig. 7-7) is directly controlled by the plunger and the sensor medium (expanding/contracting wax) assembly, which is mounted in the flow stream of the condenser exit line (fig. 7-8). The temperatures at the hot and cold inlets to the valve are controlled by the hot premixing valve and the cold premixing valve. An off-nominal condition in either of these three valves could result in abnormal condenser exit temperatures.

Figure 7-7 is typical of both the hot and cold premixing valves, and similar to the condenser exit temperature control valve. The wax expands as it heats, forcing the plunger out of the housing, gradually closing off the hot fluid inlet, and gradually opening the cold fluid inlet. Swelling of the Viton boot by fuel cell coolant absorption would tend to shift the valve setting so as to admit more cold and less hot fluid. A similar 8° to 10° F shift occurred during fuel cell development because of swelling of the Viton boot.

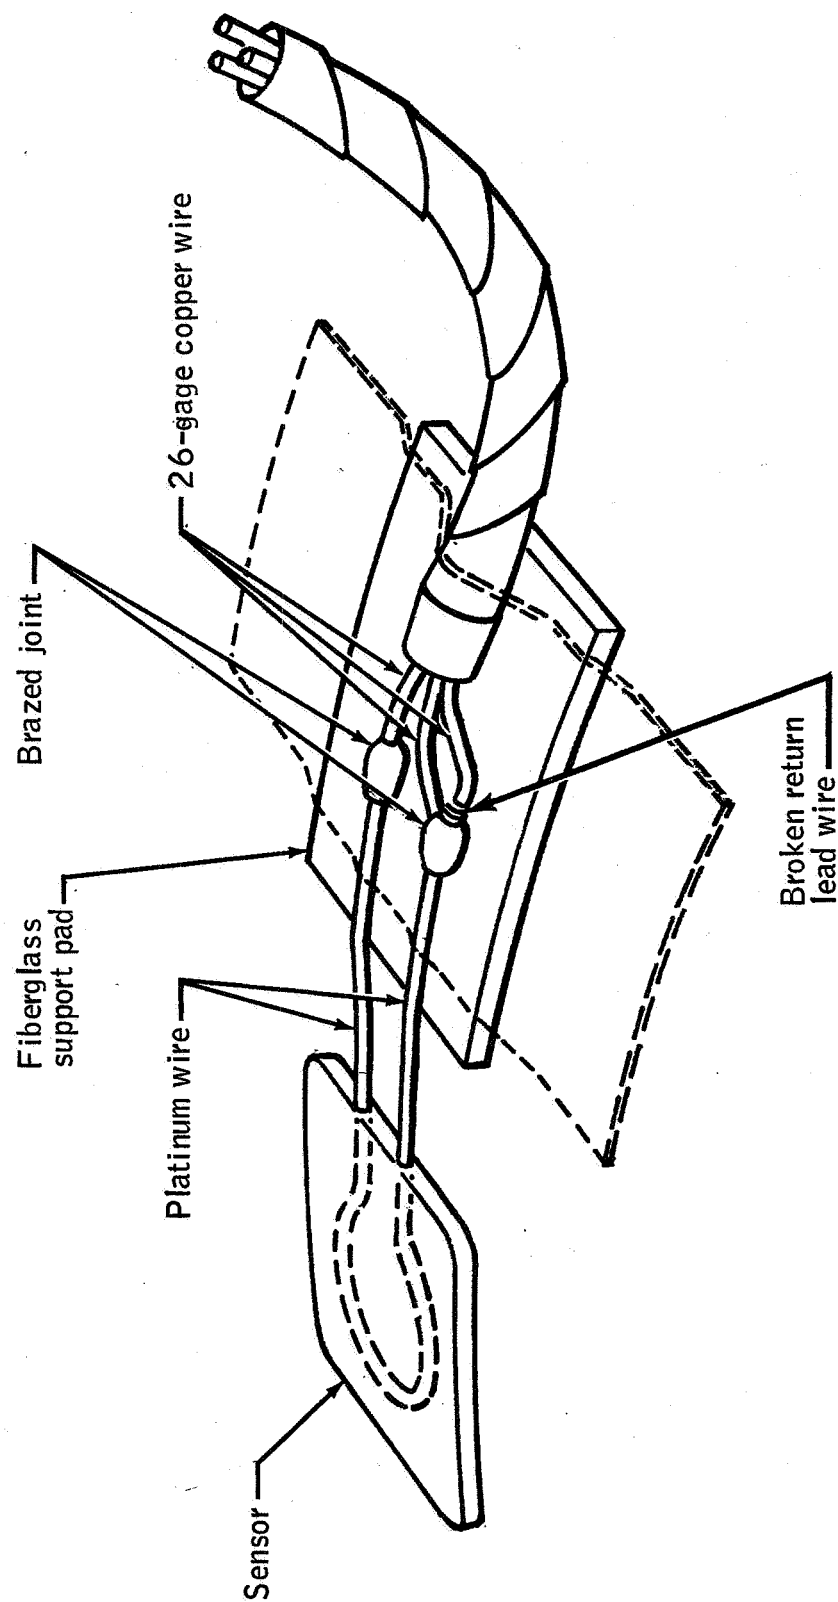
Figure 7-9.- Auxiliary power unit temperature measurement.

During operation of auxiliary power unit 1 on captive-active flight 3, the exhaust duct temperature reading went off-scale high and triggered the caution and warning signal. The redundant measurement, not displayed in the cabin, showed normal temperature readings which indicated that the off-scale high reading was probably the result of an open circuit. Postflight examination confirmed that the sensor lead had broken at the flex stress joint adjacent to the brazed joint support clamps.

Postflight examination confirmed that a break existed on the copper wire side of the platinum-to-copper-wire brazed joint of the power return from the sensor. The inspection also revealed that the fiberglass support pad between the brazed joint and the exhaust duct wall was degraded, charred, and crystallized (fig. 7-9).
